**HYDRAULIC MODEL  
INVESTIGATION**

TECHNICAL REPORT NO. 184-1

**Spillway Tailwater Channel Erosion at  
Little Goose Dam  
Snake River, Washington**

**SPONSORED BY  
U. S. ARMY CORPS OF ENGINEERS  
WALLA WALLA**

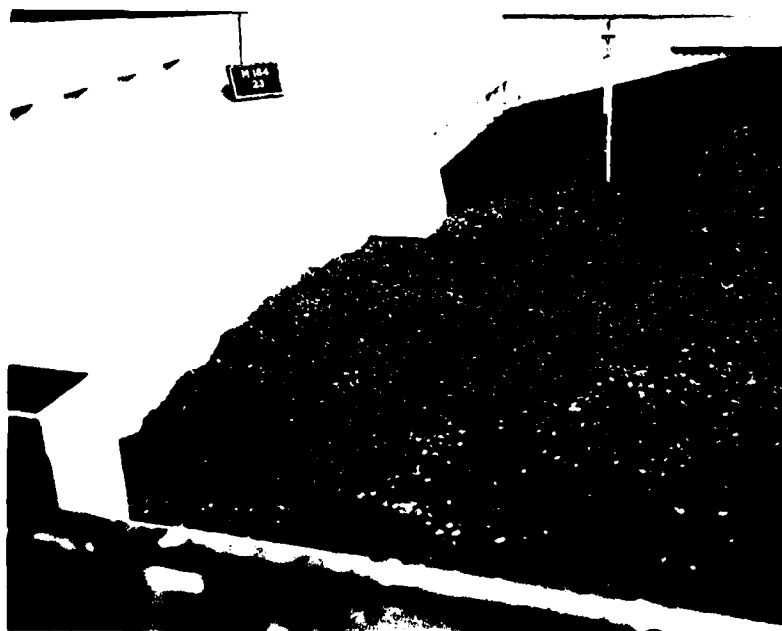
Photograph 9

Channel topography after river discharge 160,000 cfs  
with spillway discharge 96,600 cfs

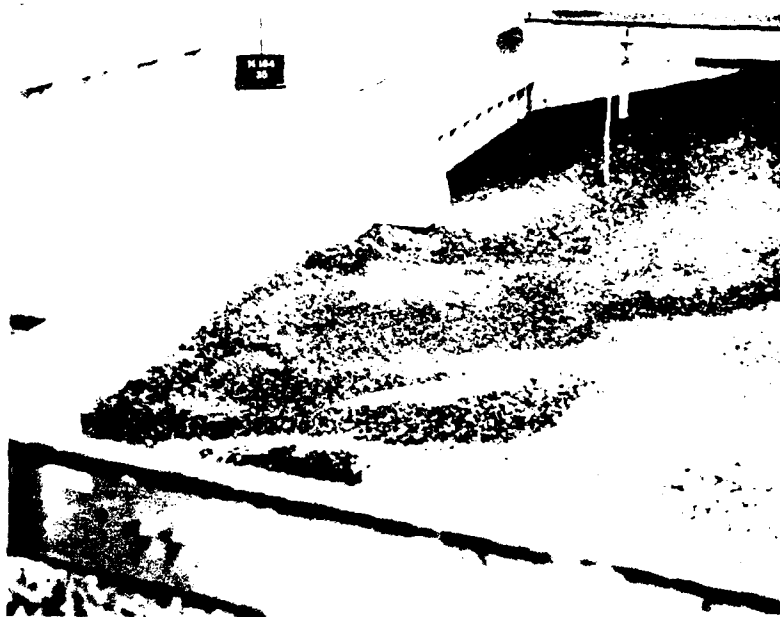
Photograph 14

Channel topography after discharge 200,000 cfs  
with spillway discharge 133,000 cfs

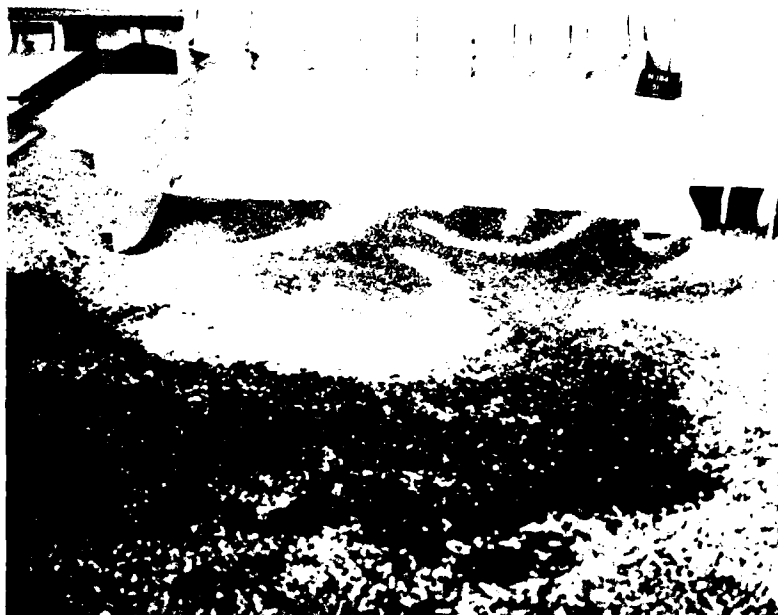
Photograph 25

Channel topography after river discharge 280,000 cfs  
with spillway discharge 214,000 cfs

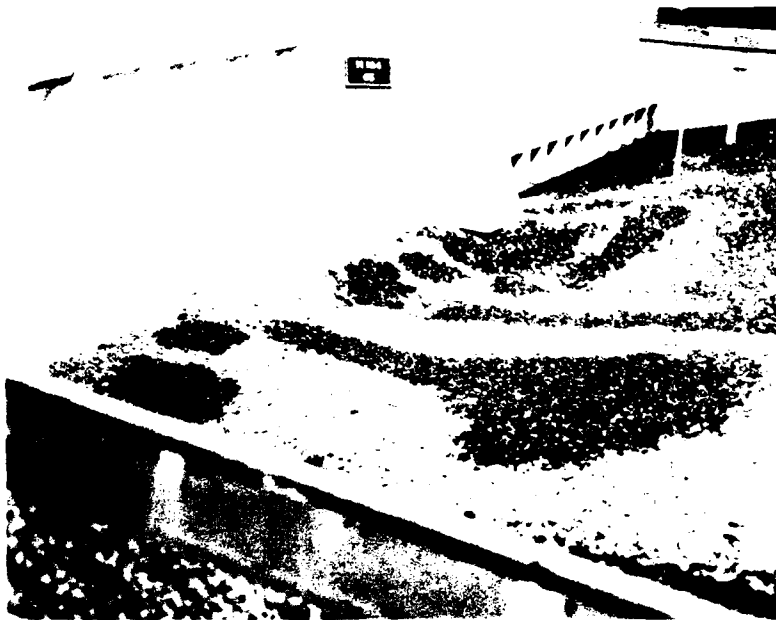
Photograph 32

Channel topography after river discharge 300,000 cfs  
with spillway discharge 234,000 cfs

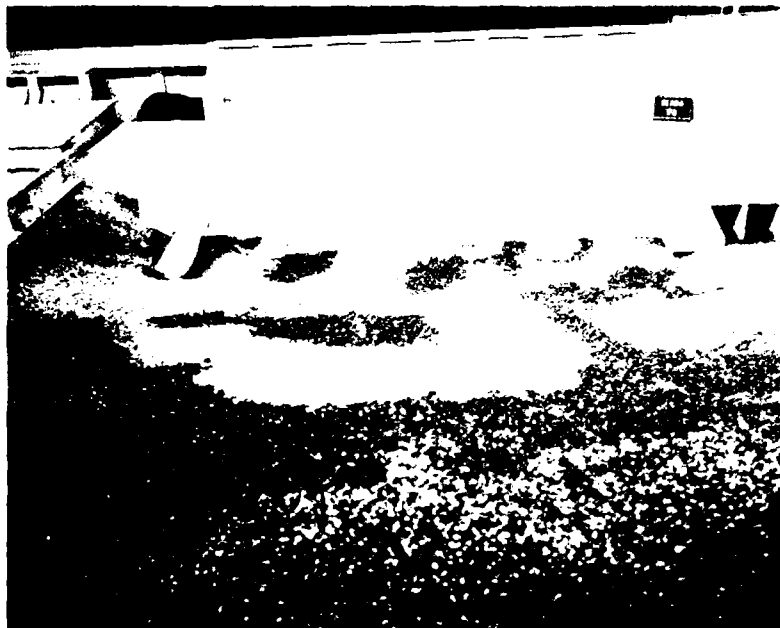
Photograph 39

Channel topography after river discharge 350,000 cfs  
with spillway discharge 284,000 cfs

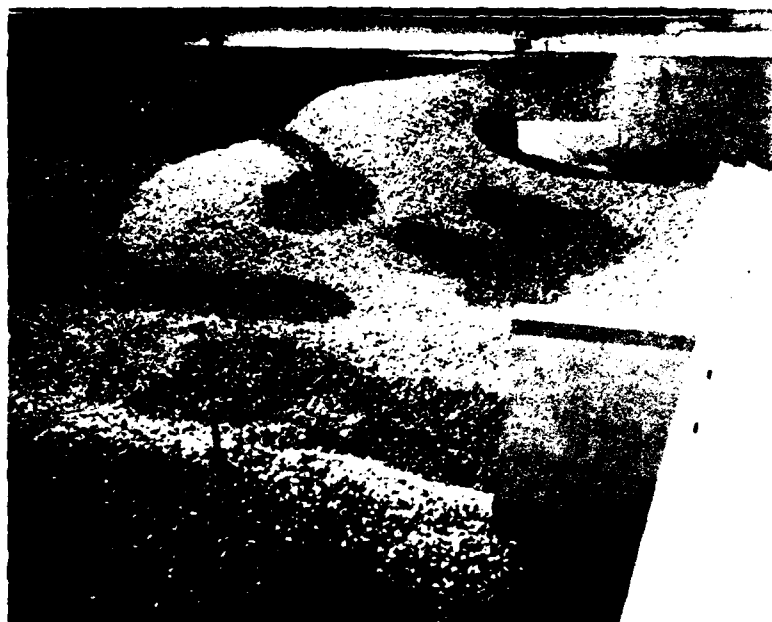
Photograph 57

Channel topography after river discharge 420,000 cfs  
with spillway discharge 354,000 cfs

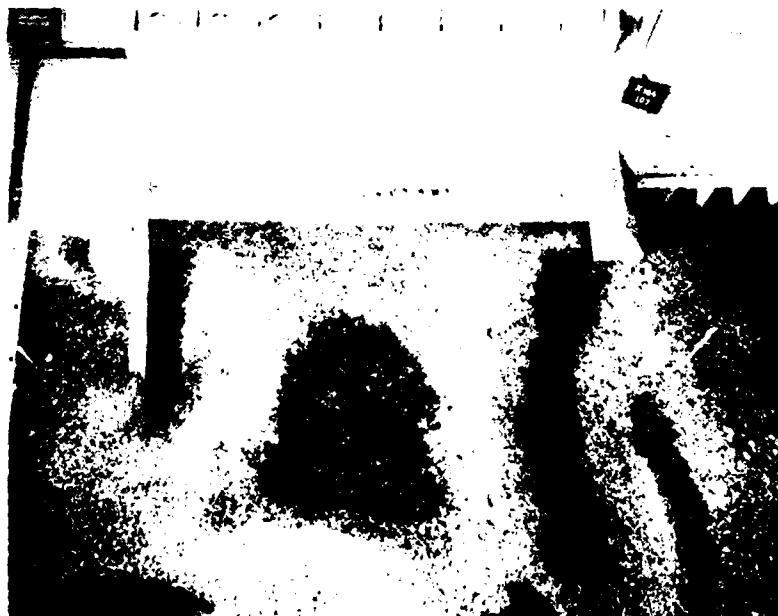
Photograph 62

Channel topography after river discharge 475,000 cfs  
with spillway flow only
